Proceedings of the Forty-Second Turbomachinery Symposium  
October 1-3, 2013, Houston, Texas

## **ELECTRIC DRIVEN CENTRIFUGAL COMPRESSOR – SUPER SYNCHRONOUS VIBRATIONS OF THE HIGH SPEED SHAFT LINE: OBSERVATIONS, ASSESSMENT AND RESOLUTION**

## ABSTRACT

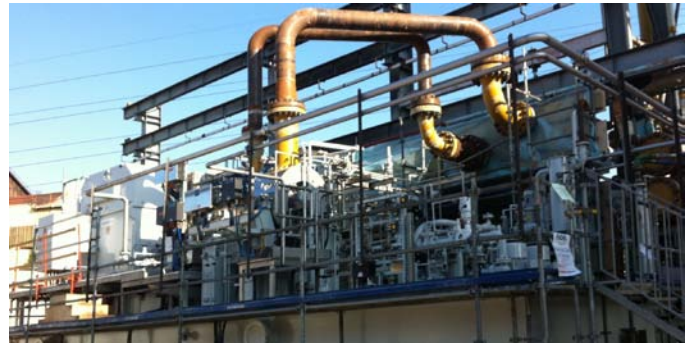
*Figure 4: HP1 gas compressor package on the test facility, Le Creusot, France*
